Presentation overview

Offshore - United Arab Emirates

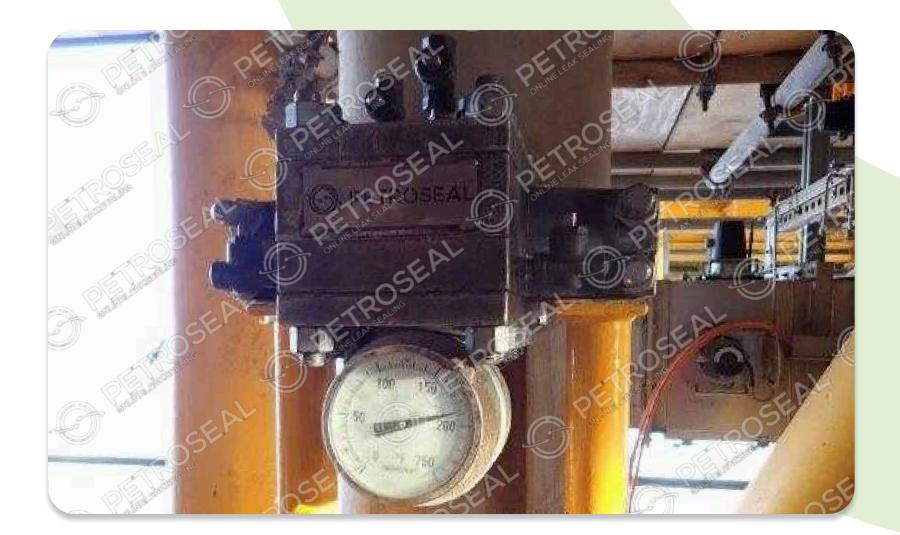
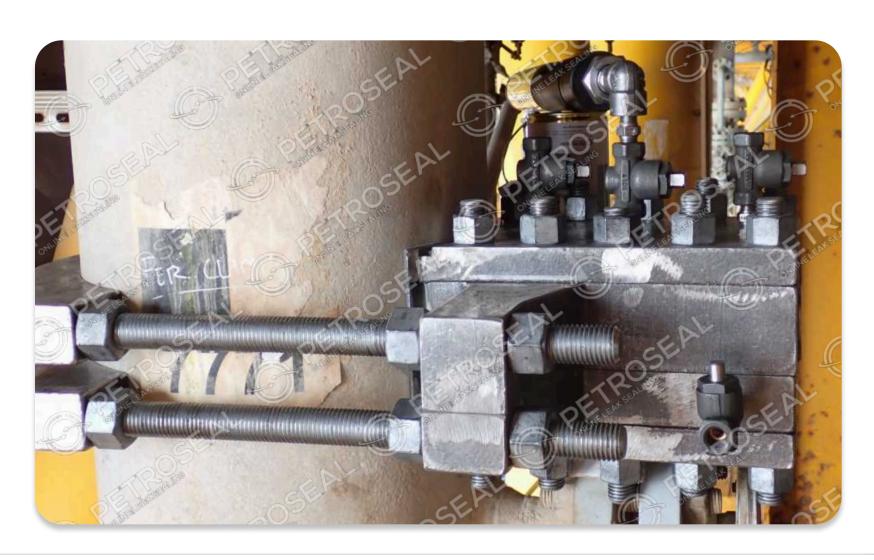
- A thermographic inspection was carried out on the main pipe connection.
- The internal thickness measured less than 2 mm.

High probability of leakage.

Installation of a compression enclosure to anticipate any leakage and secure the equipment.

- July 2025: Detection and reporting of the potential leak.
- Early August 2025: Solution validated by the client.
- August 17, 2025: Installation of the protection box.

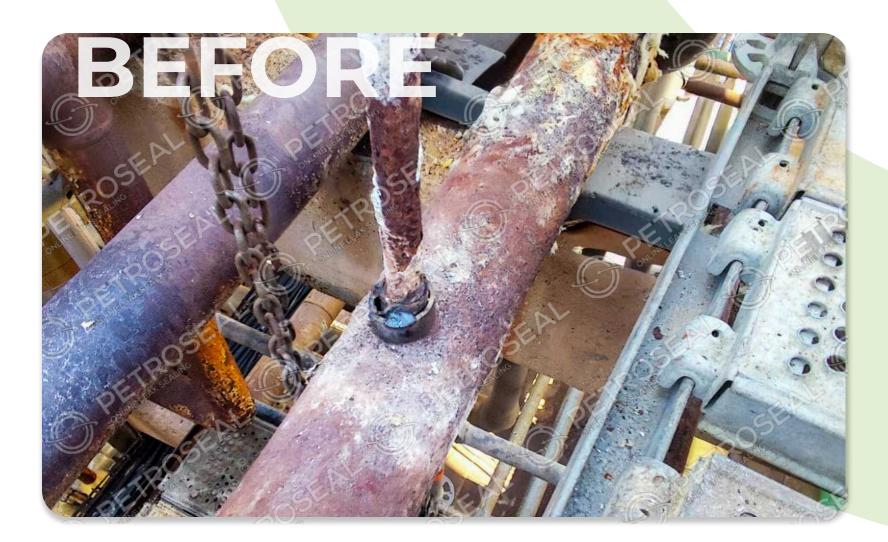
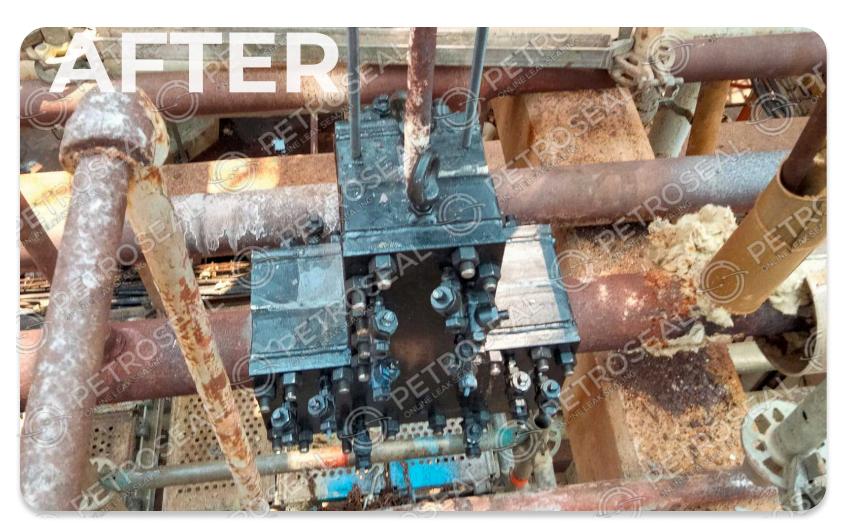
Fertilizer - Spain

Leak detected at the junction of two lines forming a T.

Fragile junction requiring specific reinforcement.

Installation of a T-enclosure with a dedicated restraint system to secure the weak joint.

- Thursday, August 14, 2025 (early afternoon): Leak reported and study issued the same day.
- Tuesday, August 19, 2025: Installation carried out for the client.

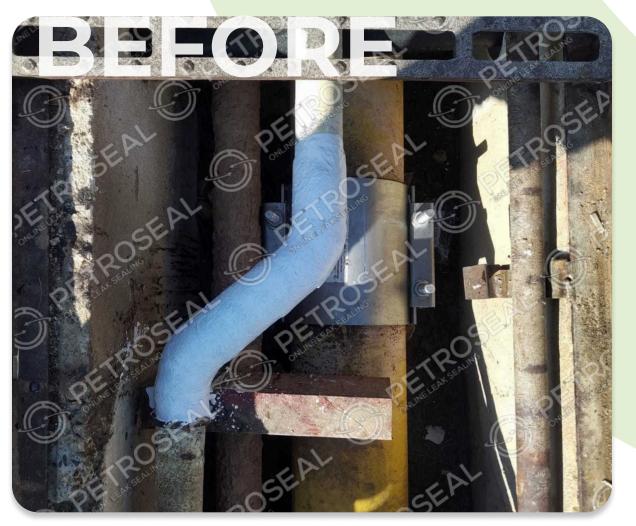
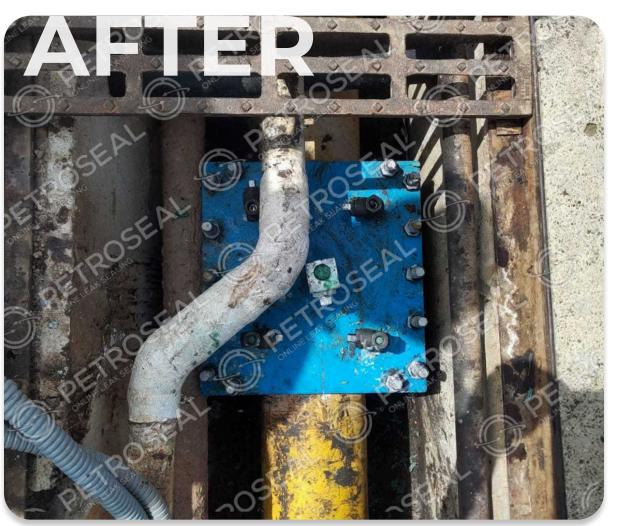
Petrochemicals - Spain

Weld crack

Very limited space due to nearby obstacles, and the need to integrate a clamp already installed by the end user as a temporary securing.

Design and installation of a custom-made enclosure, tailored to the restricted environment and accommodating the pre-existing clamp.

- Case received on 21/08/2025, study sent the same day
- Fabrication was carried out by the client, with installation completed on 25/08/2025.

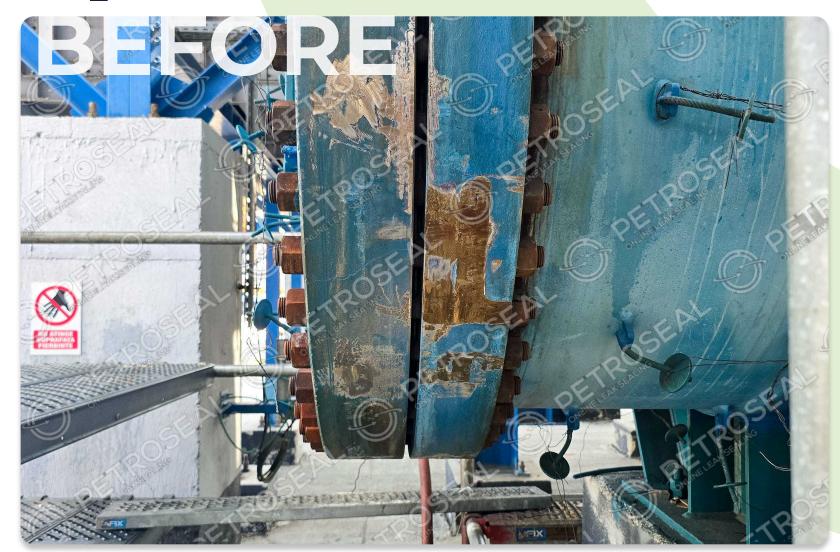
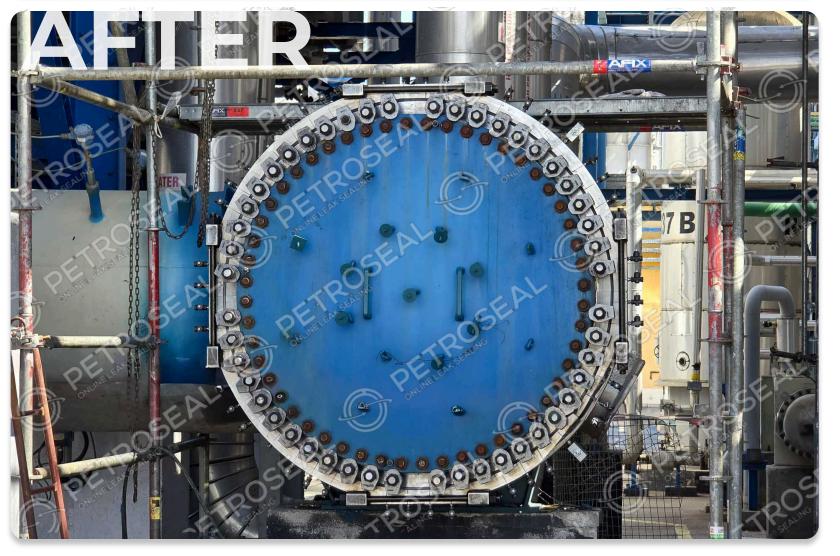
Refinery - Romania

Exchanger head: Flange gap leak

Leak at the interflange of an exchanger head. The large diameter and multiple small obstacles around the flange made the measurement process difficult.

Measurement and installation of a custom-made injection clamp, ensuring precise fit and secure sealing despite the complexity of the environment.

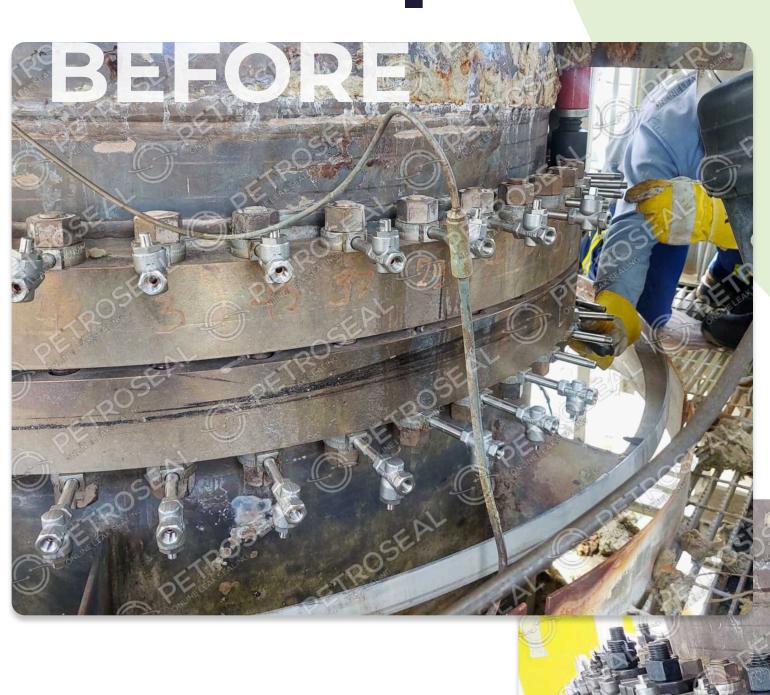
Refinery - Greece

Flange gap leak

Large-diameter leak (Ø 5190). Due to the size, the client preferred Petroseal to perform both the measurement and the installation.

Design of a custom-made injection clamp. On-site measurement, installation, and injection were carried out by Petroseal over two days.

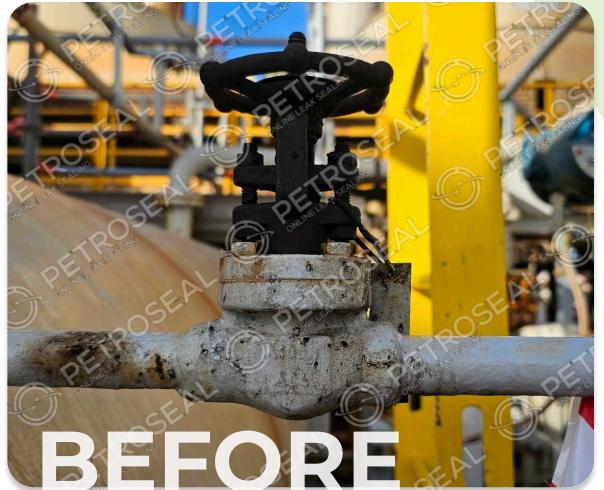
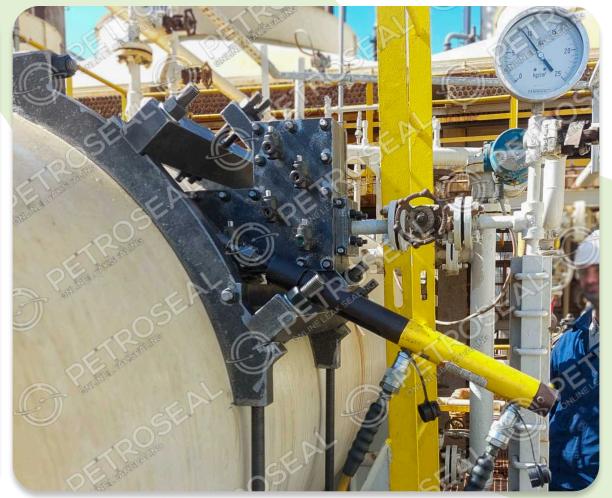
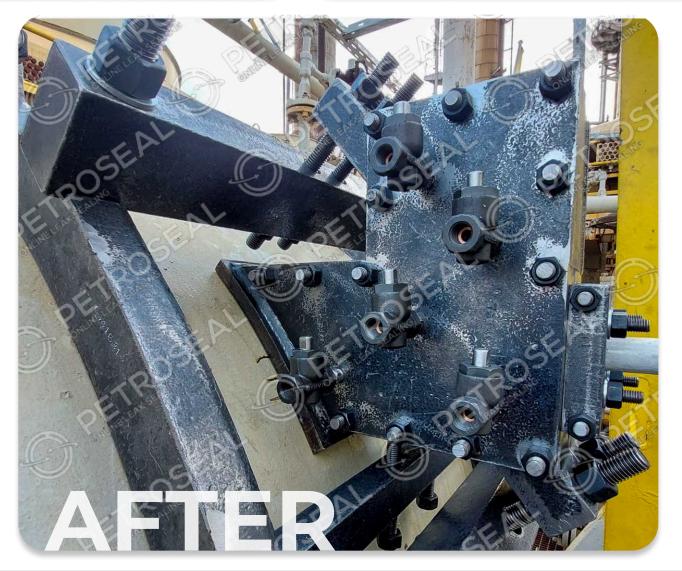
Refinery - Greece

Preventive installation following thickness measurements on critical piping for the client.

The configuration required special attention, as the corroded pipe could not support additional load.

On-site measurement and installation.

The design incorporated a compression system with weight retention on the metallic solution itself, avoiding stress on the weakened piping.

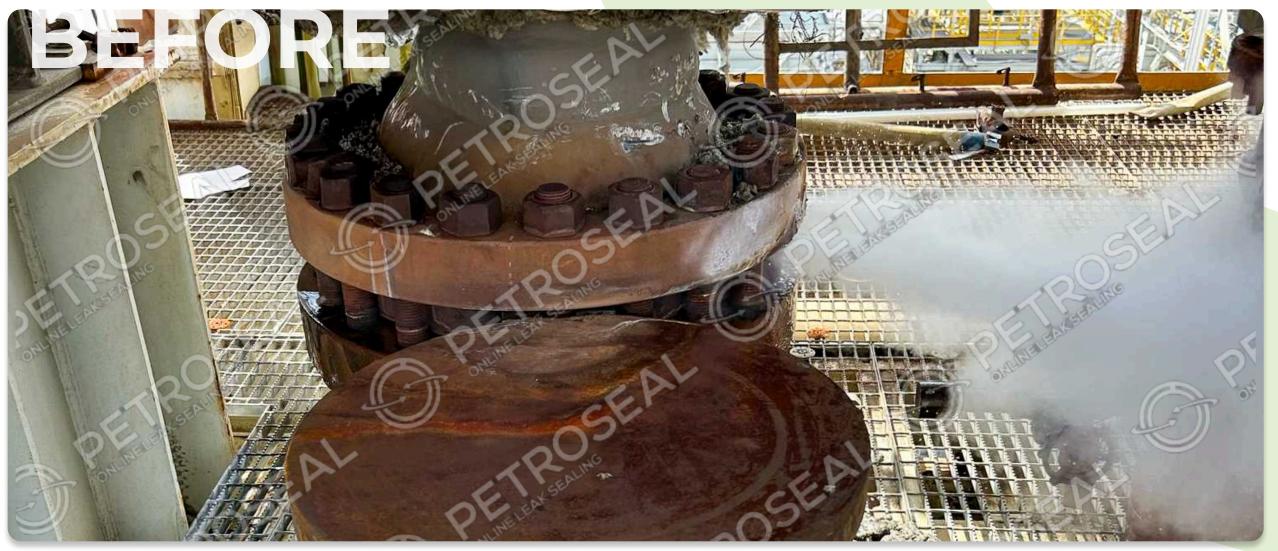
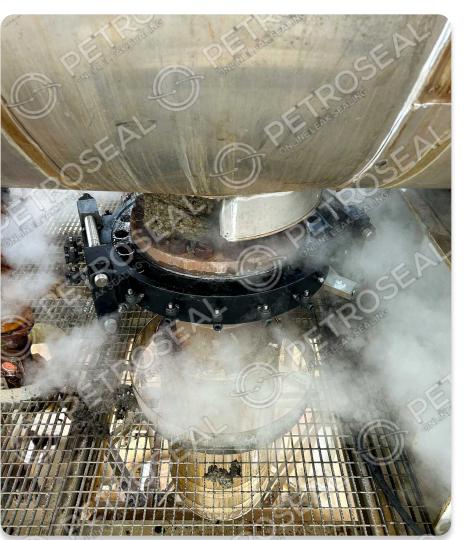
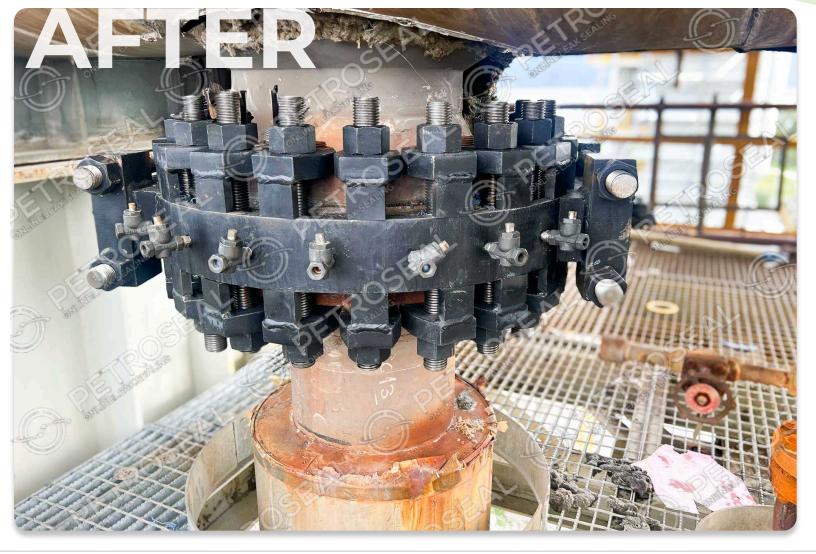
Refinery - Greece

High-pressure steam leak at the interflange area, requiring a reliable and safe solution to reassure the client under operating conditions.

The presence of a blind flange in the initial flange set required a special design to accomodate the geometry of the remaining part of the spade after cutting it.

Design and installation of a custom-made injection clamp ensuring effective sealing and enhanced confidence in operation.

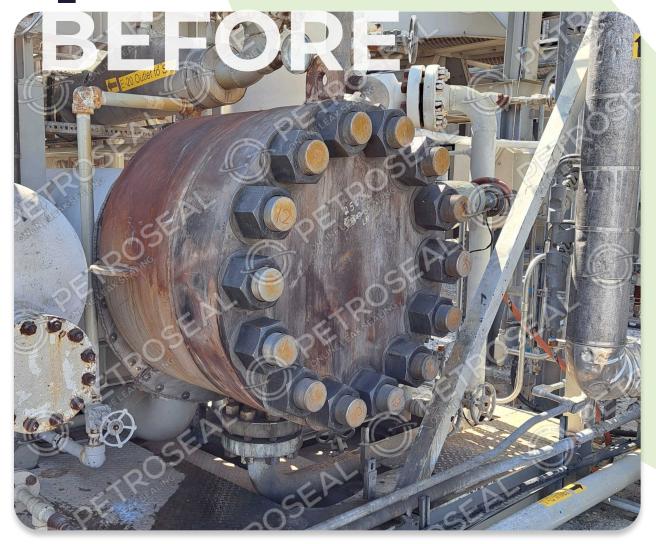
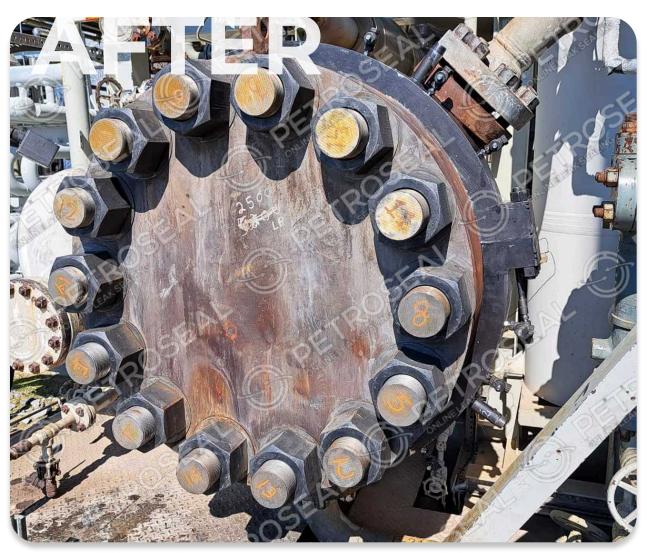
Fertilizer - United States of America

3 235°C **2** 50 Bar

Leak bypass

A complex gas mixture: Ammonia, Hydrogen, Nitrogen, Argon, and Methane

Installation of a custom-made clamp, with two grooves for the compression of the packing and one groove to divert the leak to the outside.

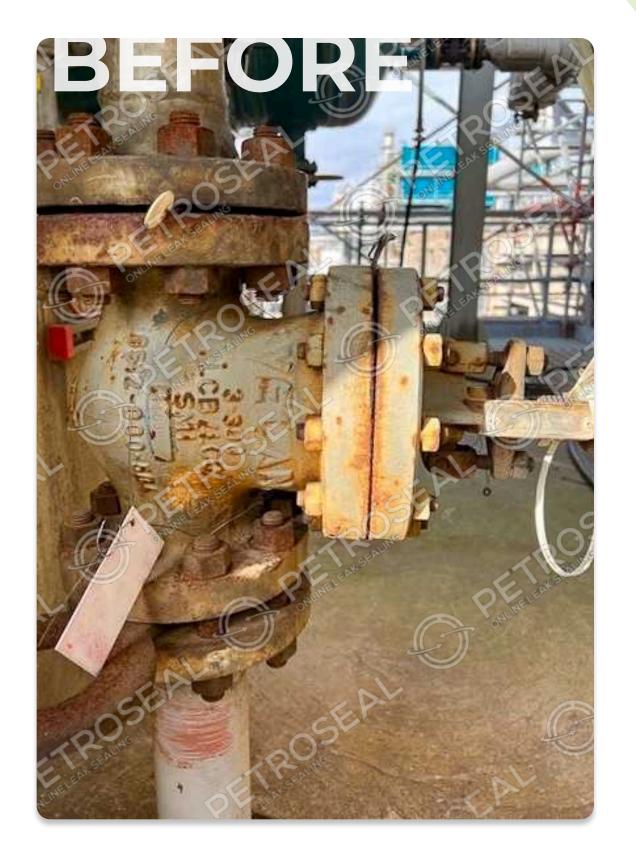
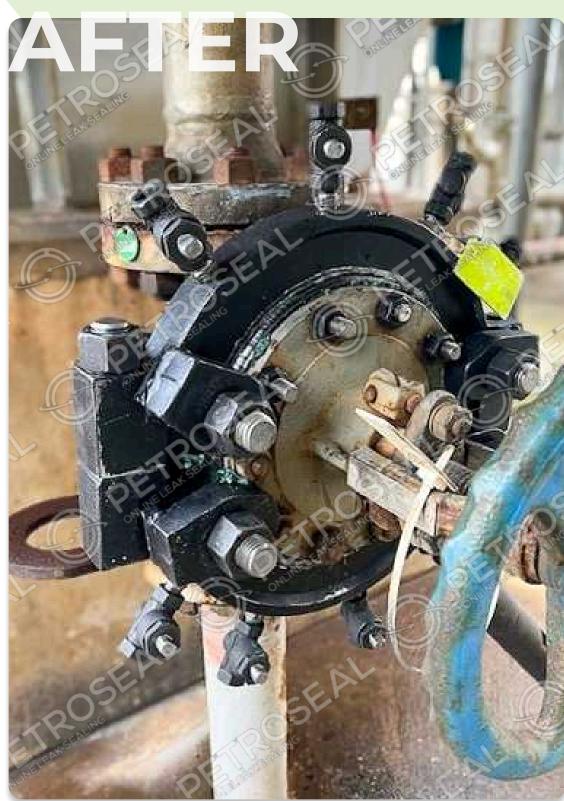
Refinery - Sweden

68°C **2**0 Bar

Gas leak at the bonnet flange

Very narrow flange gap and tilted flanges

Installation of a classical clamp with stiffeners and a narrow central lip.

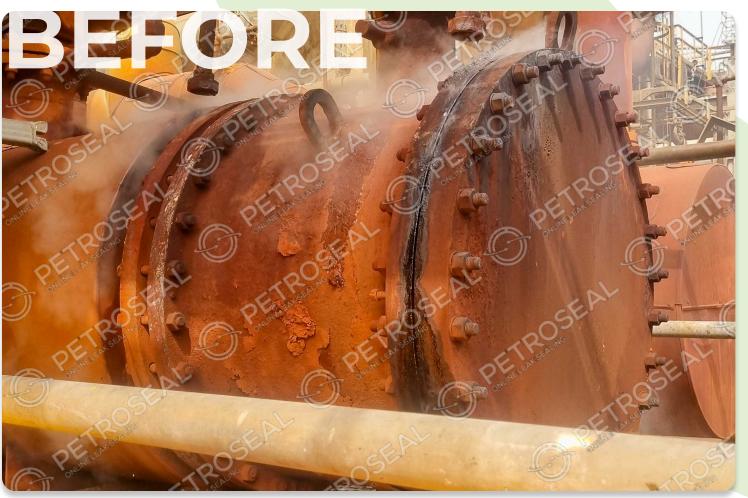
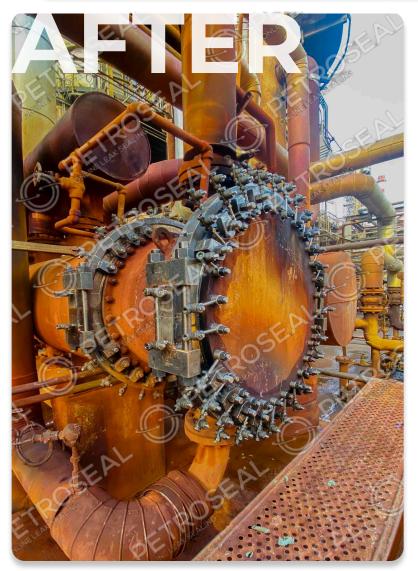
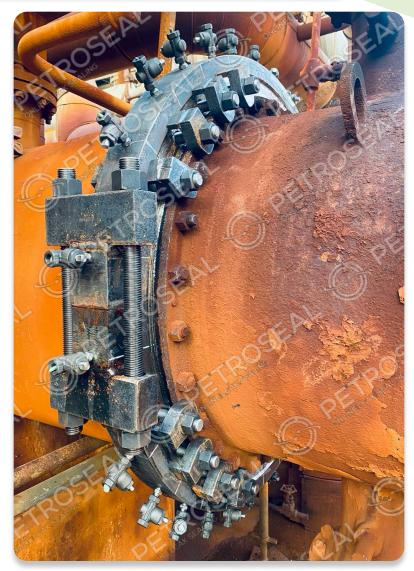
Refinery - Ivory Coast

Oil leak on a critical heat exchanger in the cracking unit of the refinery.

Leak on two Ø1100 flanges, one flat face and one raised face.

On-site measurement and manufacturing within 48h – installation in Ivory Coast within 5 days.

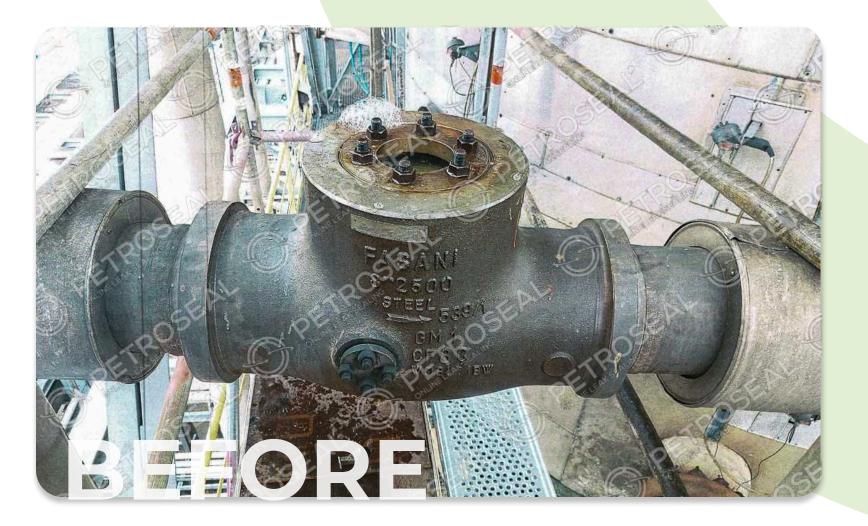
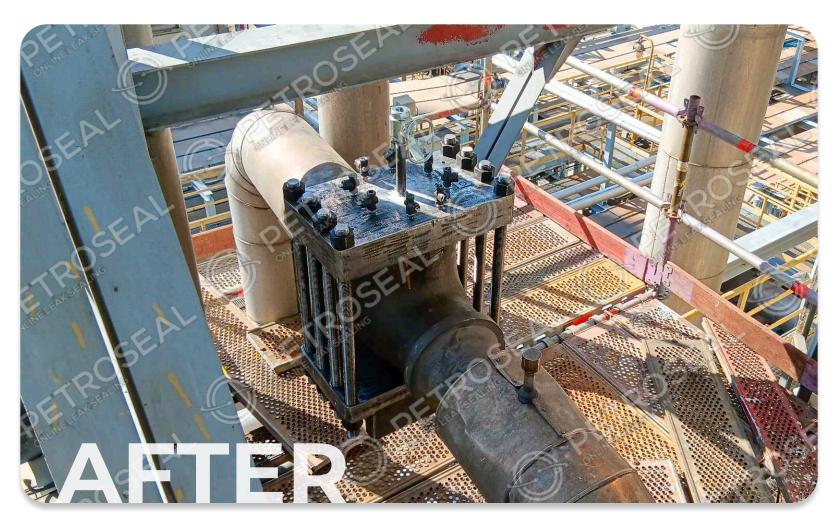
Refinery - Poland

Leak on an autoclave valve.

A complex case both in terms of design, due to the specific operating conditions of an autoclave valve. And in terms of installation, involving a high-temperature environment and injection operations, particularly when handling hydrogen.

Design and installation of a custom-made enclosure

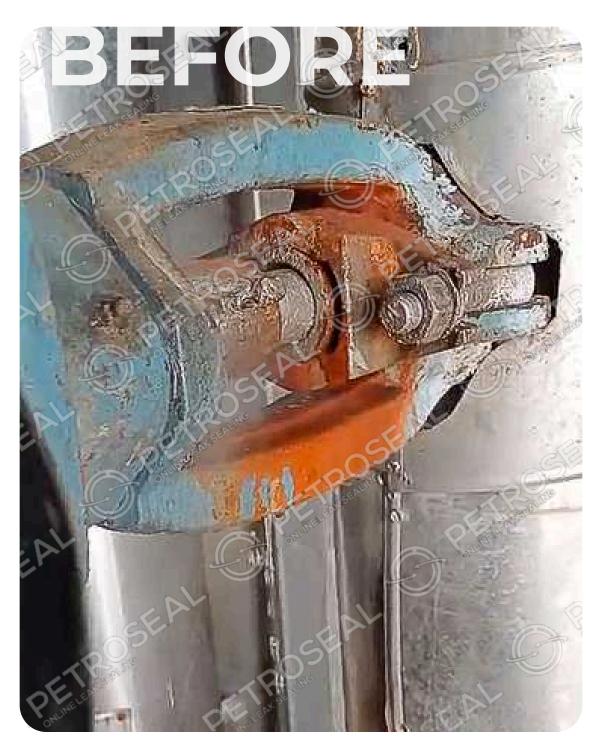
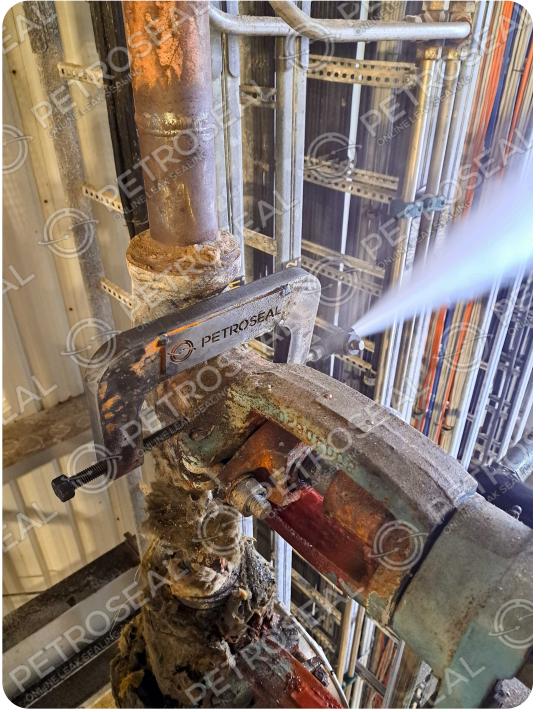
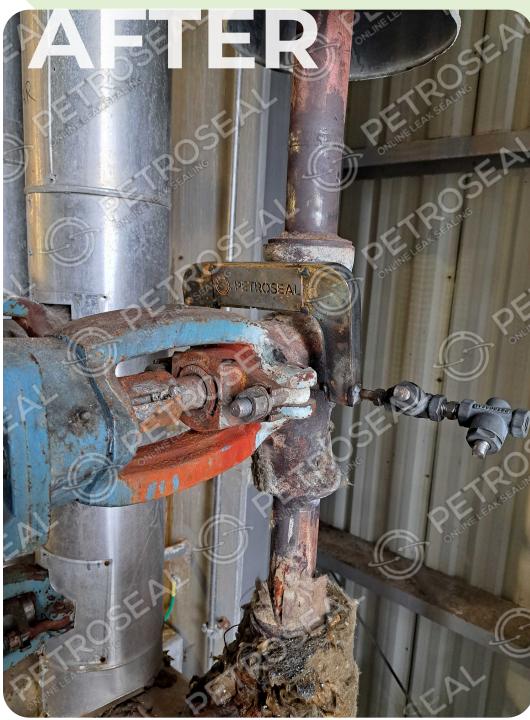
Pulp and paper mill - Uruguay

G-clamp

Packing leak on a valve.

Design of G-clamp, and installation by Petroseal during the training session, allowing the execution of a real case.
